USAAEFA PROJECT NO. 77-22

PRELIMINARY AIRWORTHINESS EVALUATION
OV-1D AIRPLANE WITH AN/ALQ-147
XE-1 AND XE-2 SYSTEMS INSTALLED

FINAL REPORT

February 1978

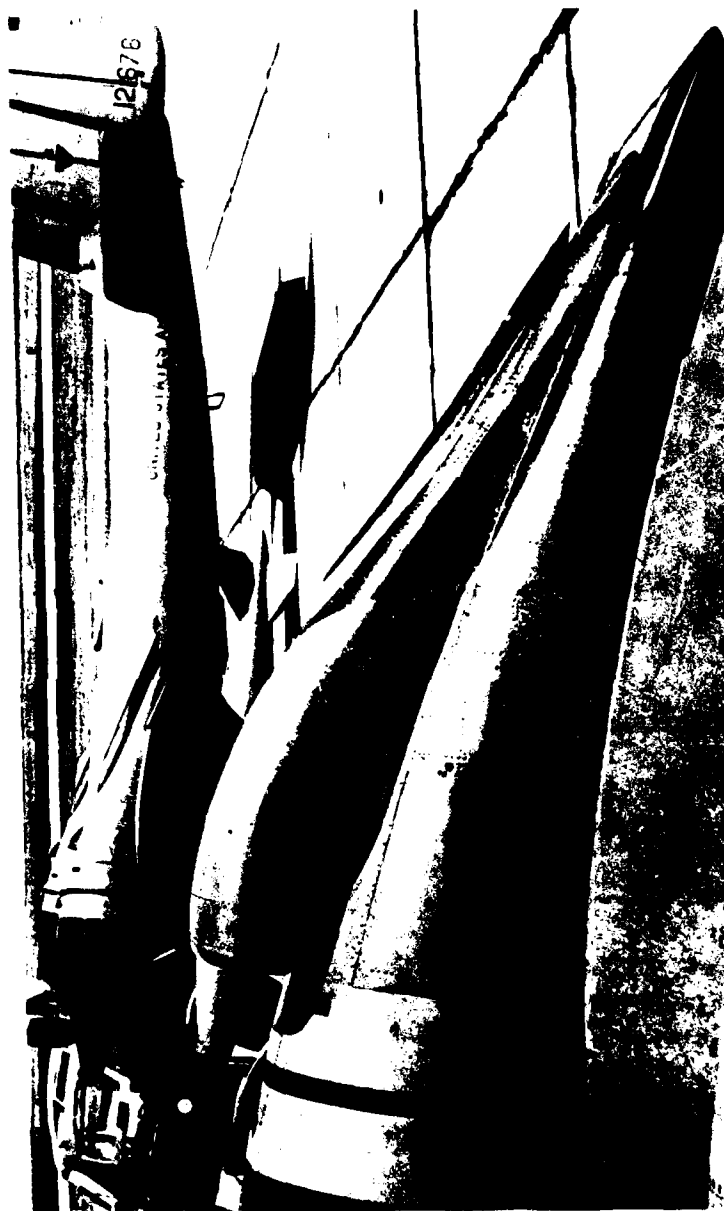
Photo 7. LSSS Installed on OV-1D.

8. The louvered scarfed shroud suppressor (LSSS) is a passive IRCM device designed to reduce the IR signature of the engines installed on the OV-1D. Photos 7 through 10 show the LSSS installed on the test aircraft.

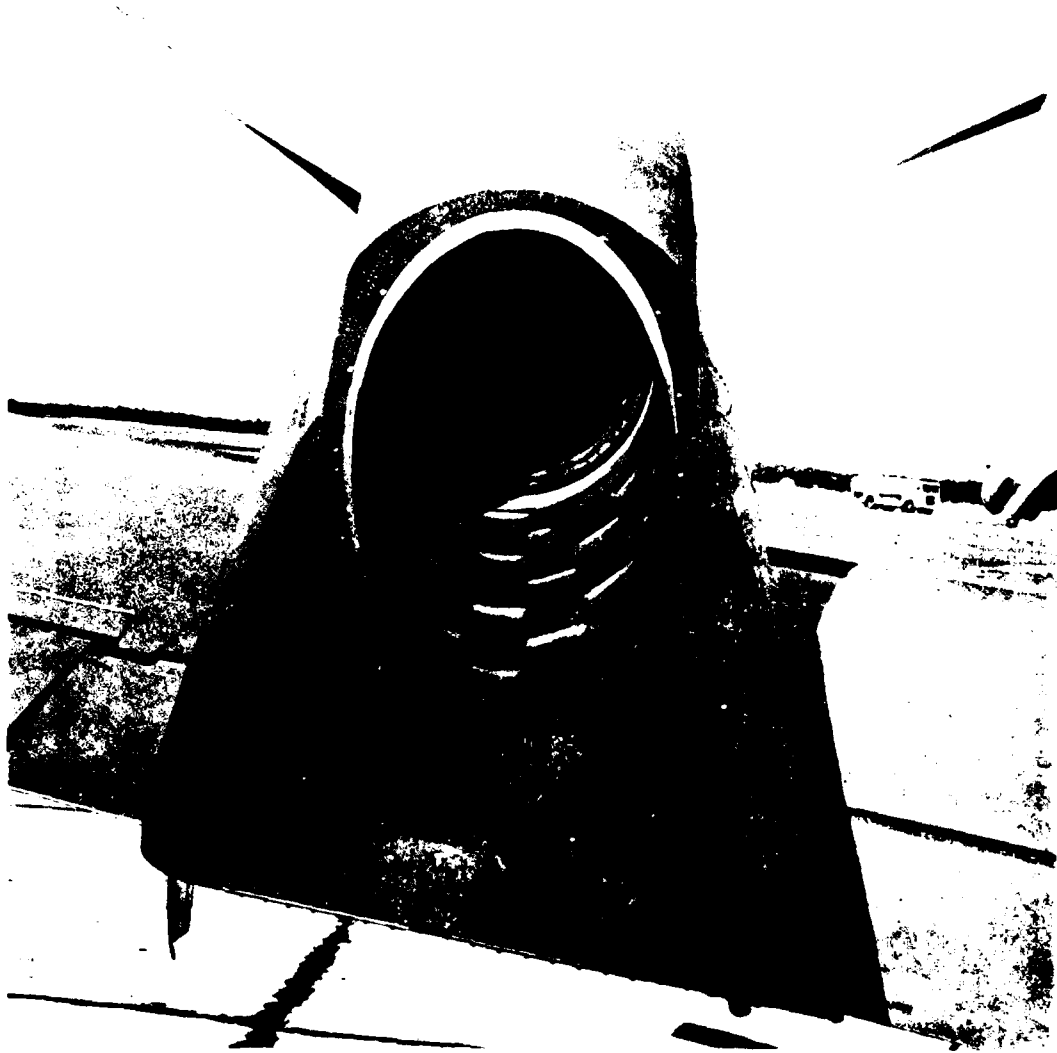
Photo 8. LSSS Installed on OV-1D (Side View).
